AW139

Lightning strike

**AW Customer Support Lunch
Orlando, 7th March 2011**

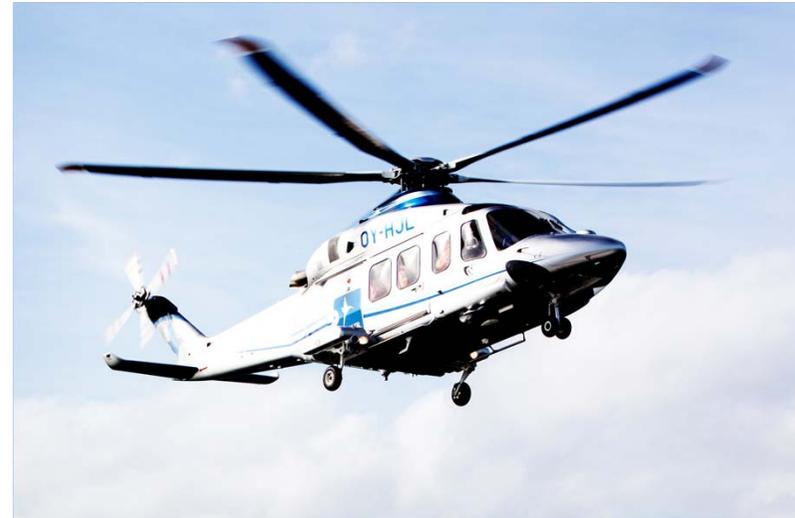
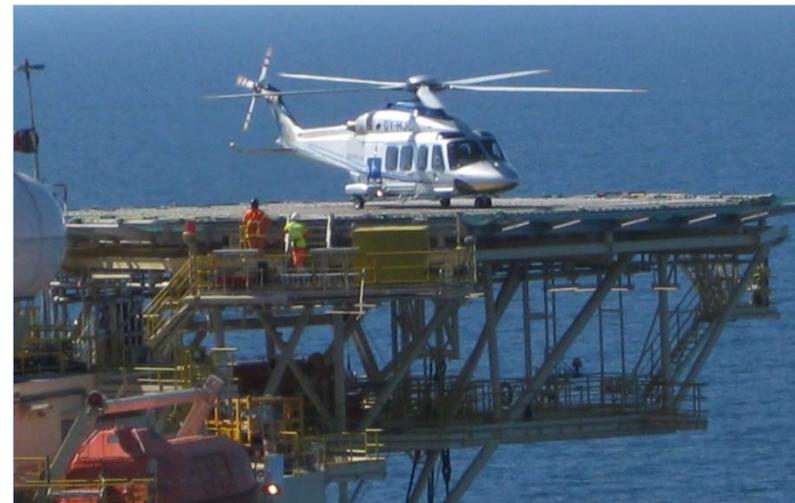
- On Saturday **27th November 2010**, our AW139 helicopter experienced a Lightning Strike during an offshore mission.
- Weather was snowy and no thunderstorm activity in the area.
- During cruise, the pilots heard a loud bang outside followed by a CAS message HEATED WINDSHIELD FAIL.
- Pax went back to sleep again – so he felt as comfortable as the pilots themselves.
- The helicopter flew further 20 minutes to the platform and landed without noticing any problems.

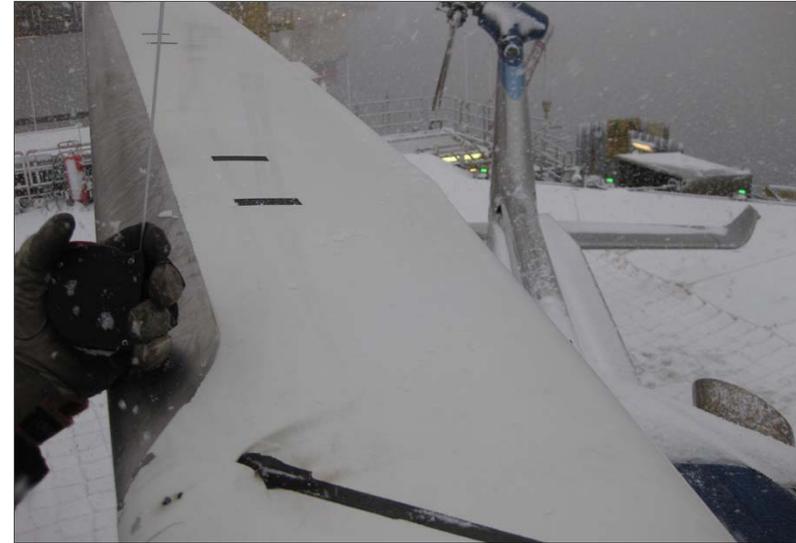
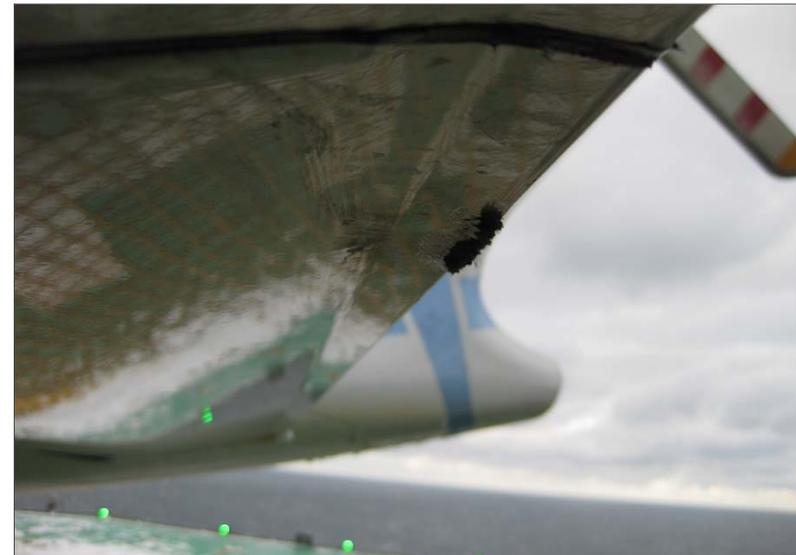
- After landing our Bel Air technician noticed damages on the tail plane and on four MR Blades.
- The helicopter was AOG on the platform.
- We contacted AW 24.7 Fleet Operations Centre and additional manpower from Bel Air was send to the platform right away.
- As a natural solution, other helicopters was leased to fulfill the continous flight schedule for Maersk Oil.

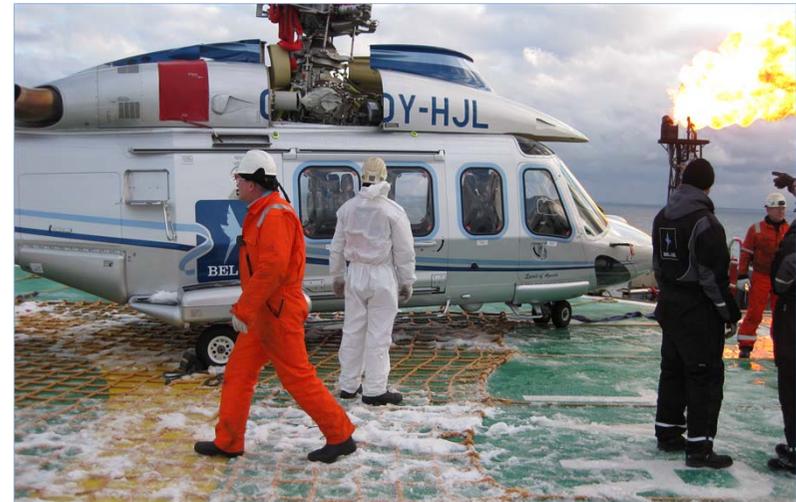
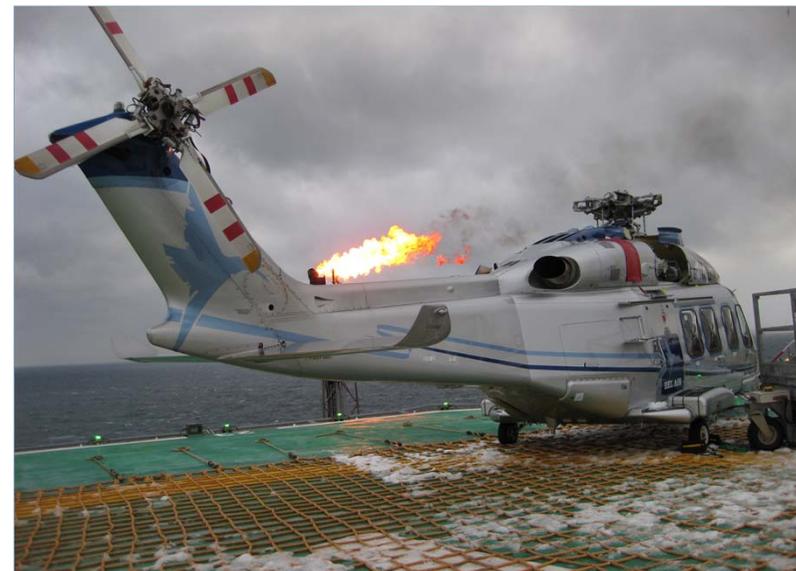
A lot of tests was performed on the platform – they were all satisfied – no fault found;

- HUMS and FDR download – all parameters normal
- All possible selftest performed
- DCU download performed
- MGB upper deck inspected
- Flight controls
- Electrical system functional checked
- Avionic system tested
- Detailed inspection of the tail and tail boom

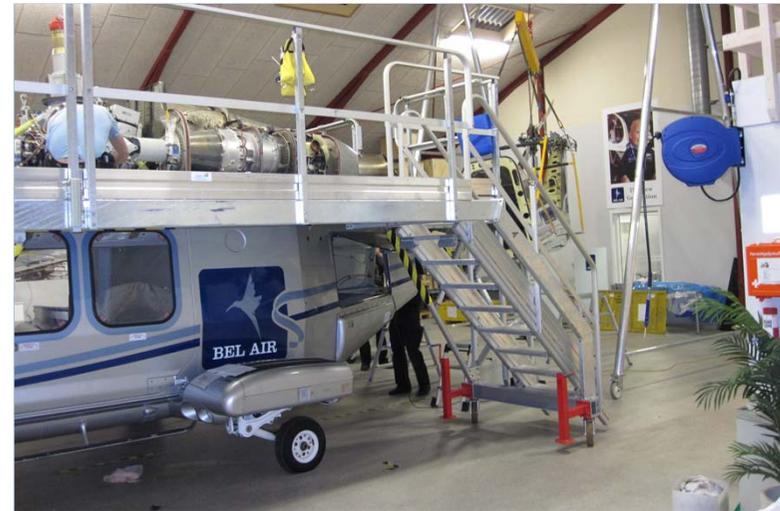
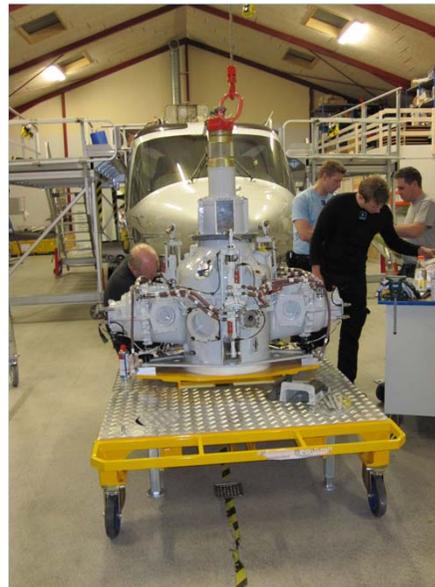
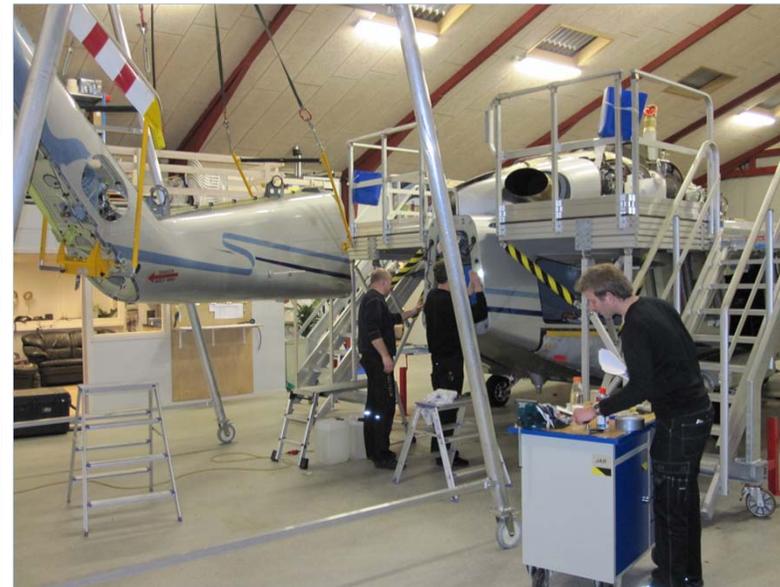
7 days inspections was made day and night by our 12 engineers:

- *MR Head (fully disassembled)*
- *MGB*
- *IGB removed for inspection*
- *Fuselage*
- *Tail boom*
- *Flight controls*
- *Hydraulic system*
- *Aft floats*
- *Avionic system*

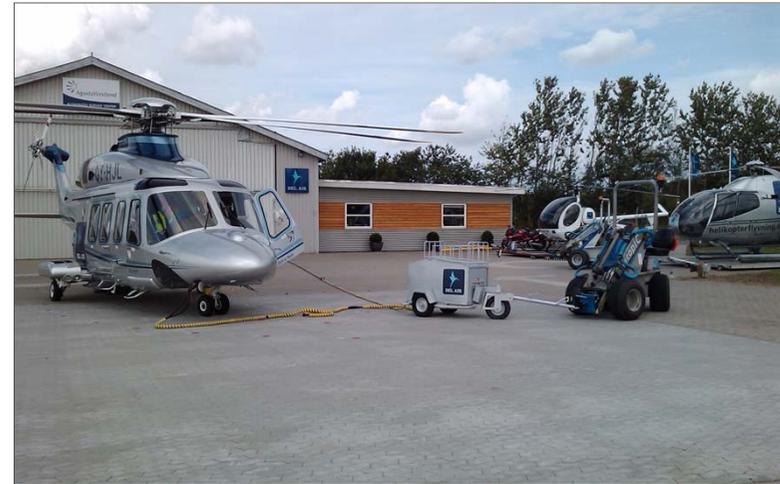
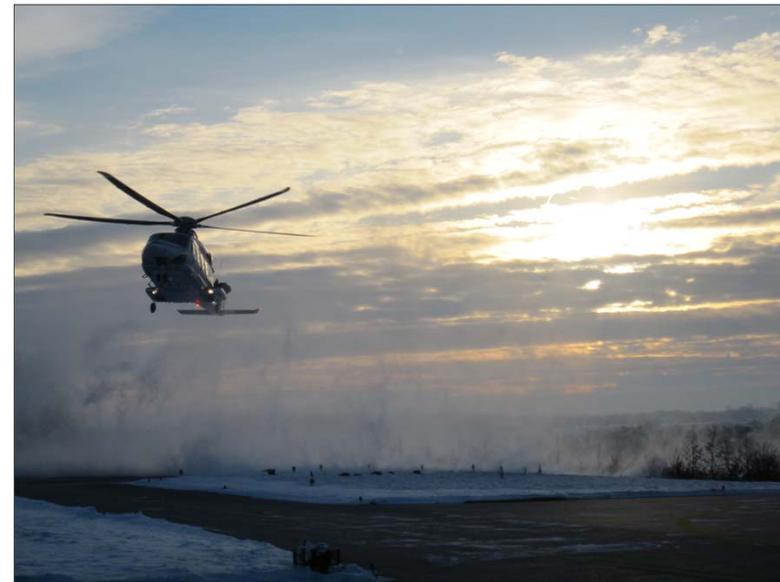
There have been no after-effects with the helicopter due to the lightning strike.

...the aircraft was finally released into service on **10th December**, having replaced:

- *Tail plane*
- *5th MR Blade*
- *MR Duplex Bearing*
- *MGB, for AW investigation*
