AW139

Lightning strike

**AW Customer Support Lunch
Orlando, 7th March 2011**

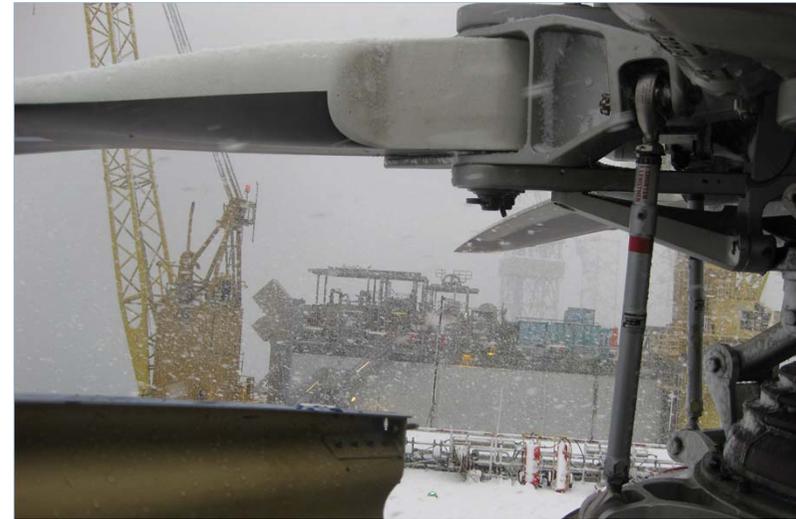
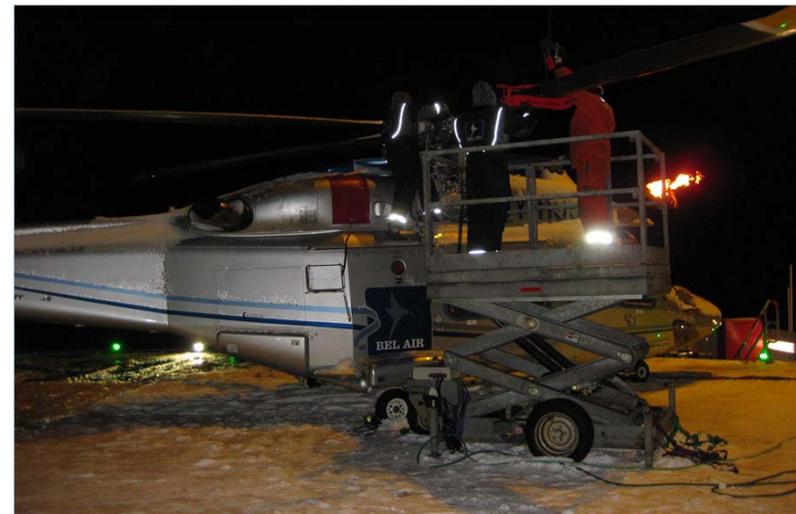
- Bel Air employees started the preliminary lightning strike inspection on the platform with support from Agusta – Maersk Oil employees, the Bel Air pilots and Bel Air engineers was a great team in this tough environment.

Everybody still remember working in windy and snowing weather conditions with a chillfactor of **-18** degrees Celcius on the platform.

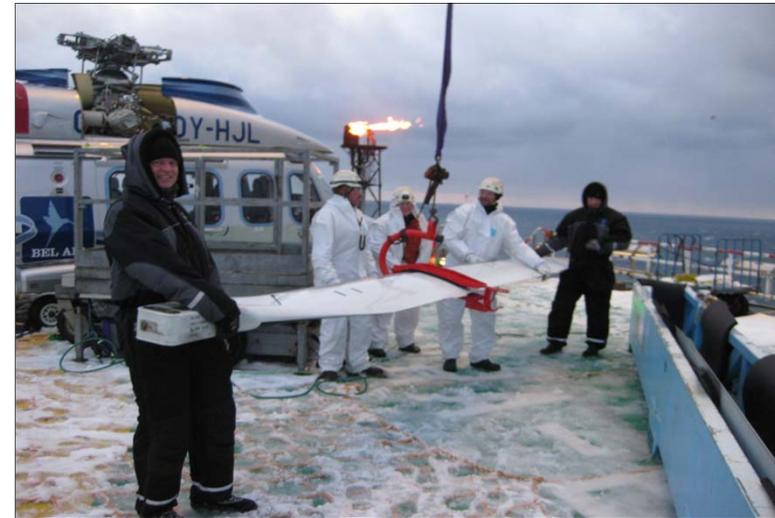
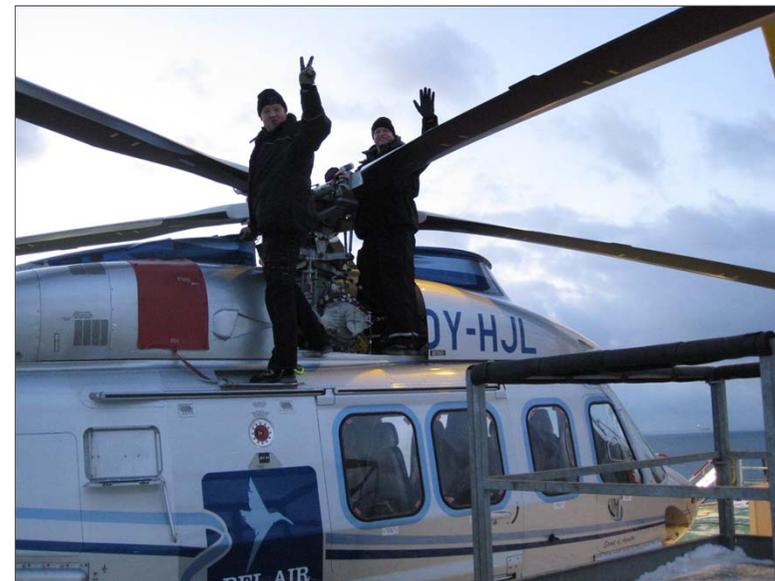
- On **30th November** the new Blades arrived at the Esbjerg offshore harbor, ready to be dispatched by a Maersk vessel.
- The vessel was able to deliver the four Blades on **2nd December**, after the weather conditions became acceptable for crane operations offshore.
- On **3rd December** EASA approved the Ferry Flight and the aircraft left the platform and landed safely at our Bel Air main base one hour later.
